**Chrysler Corporation:** AmberTech M99 Heat Reduction Test

**Model:** 2 Oilgear High Pressure Hydraulic Pumps: PVWH34L and PVWH45L

**Treatment Ratio:** AmberTech M99 was added at a rate of 2 oz. per qt. of hydraulic fluid

**Method:** Internal Computerized Ultraviolet Temperature Continuous Monitoring System

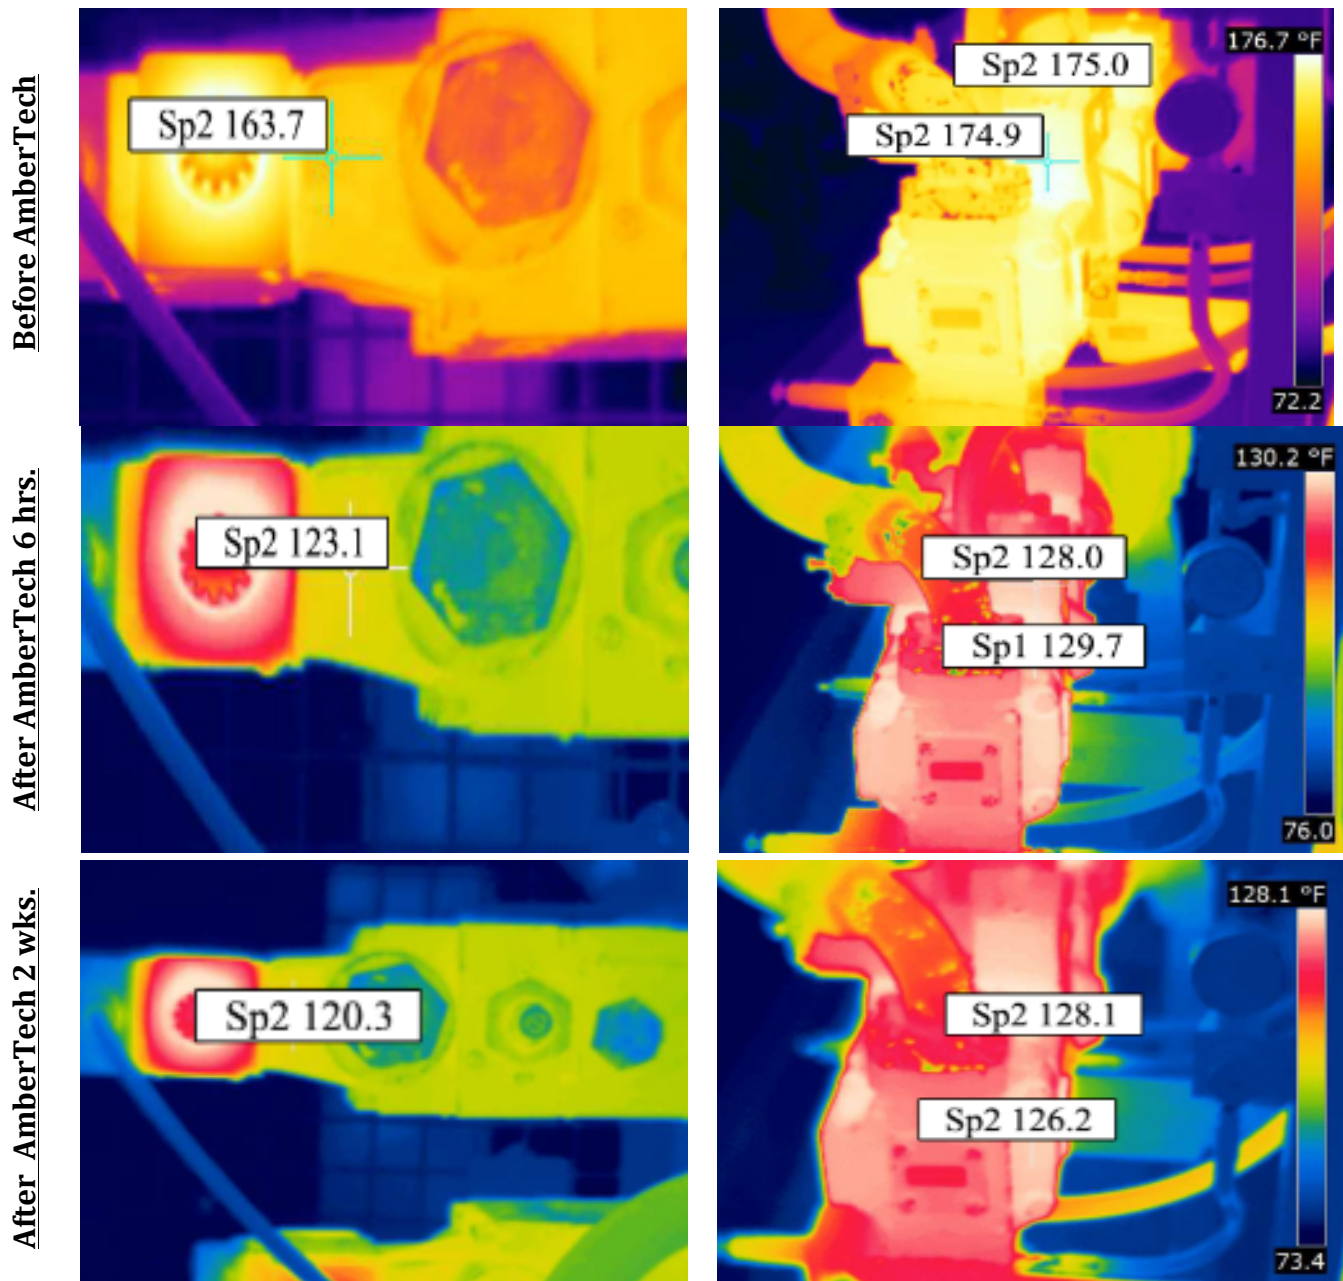
Pump/Valve	PVWH34L	PVWH45L	Valve on Manifold
Temp. Before AmberTech	174.9°F	175.0°F	163.7°F
Temp. 6 hrs. post M99 treatment	129.7°F	128.0°F	123.1°F
Temp. 2 wks. post M99 treatment	126.2°F	128.1°F	120.3°F
Total Temp. Reduction	48.7°F	46.9°F	43.4°F

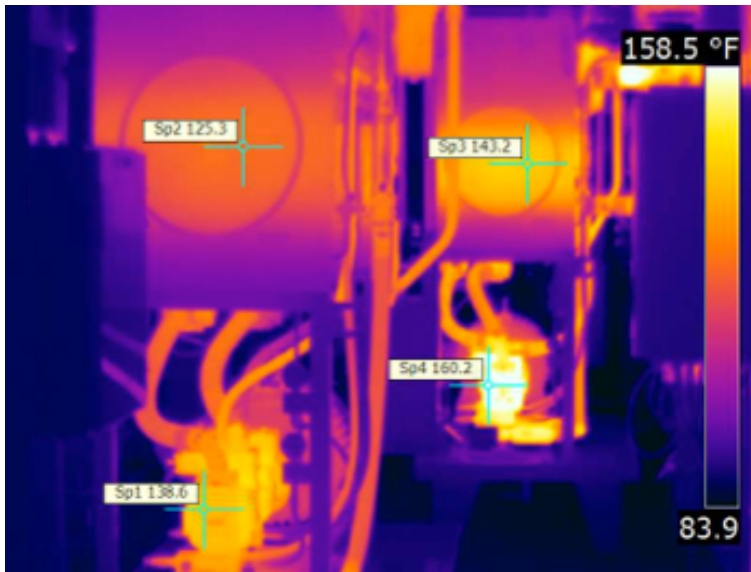
After AmberTech 3 months

## Ultraviolet Thermal Imaging Sustainability

- Temperature reductions sustained 3 months post AmberTech M99 treatment
- The Hydraulic system on the left was treated with AmberTech M99
- The Hydraulic system on the right was never treated with AmberTech M99

Hydraulic Pump	Sp1/Sp4	Sp2/Sp3
Hydraulic Pump without M99	160.2 °F	143.2 °F
Hydraulic Pump treated with M99	138.6 °F	125.3 °F
Difference in Temperature Readings	21.6 °F	17.9 °F

Hydraulic Pump	Temperature Reading
Hydraulic Pump before AmberTech M99	174.9 °F
Hydraulic Pump 3 months post AmberTech M99	138.6 °F
Temperature Reduction	36.3 °F
